# Power Resistor Sanity Check

Sanity check of the resistance calibration routine using a known power-resistor load.

| Document ID | OV-TEST-HW-RESISTOR-SANITY |

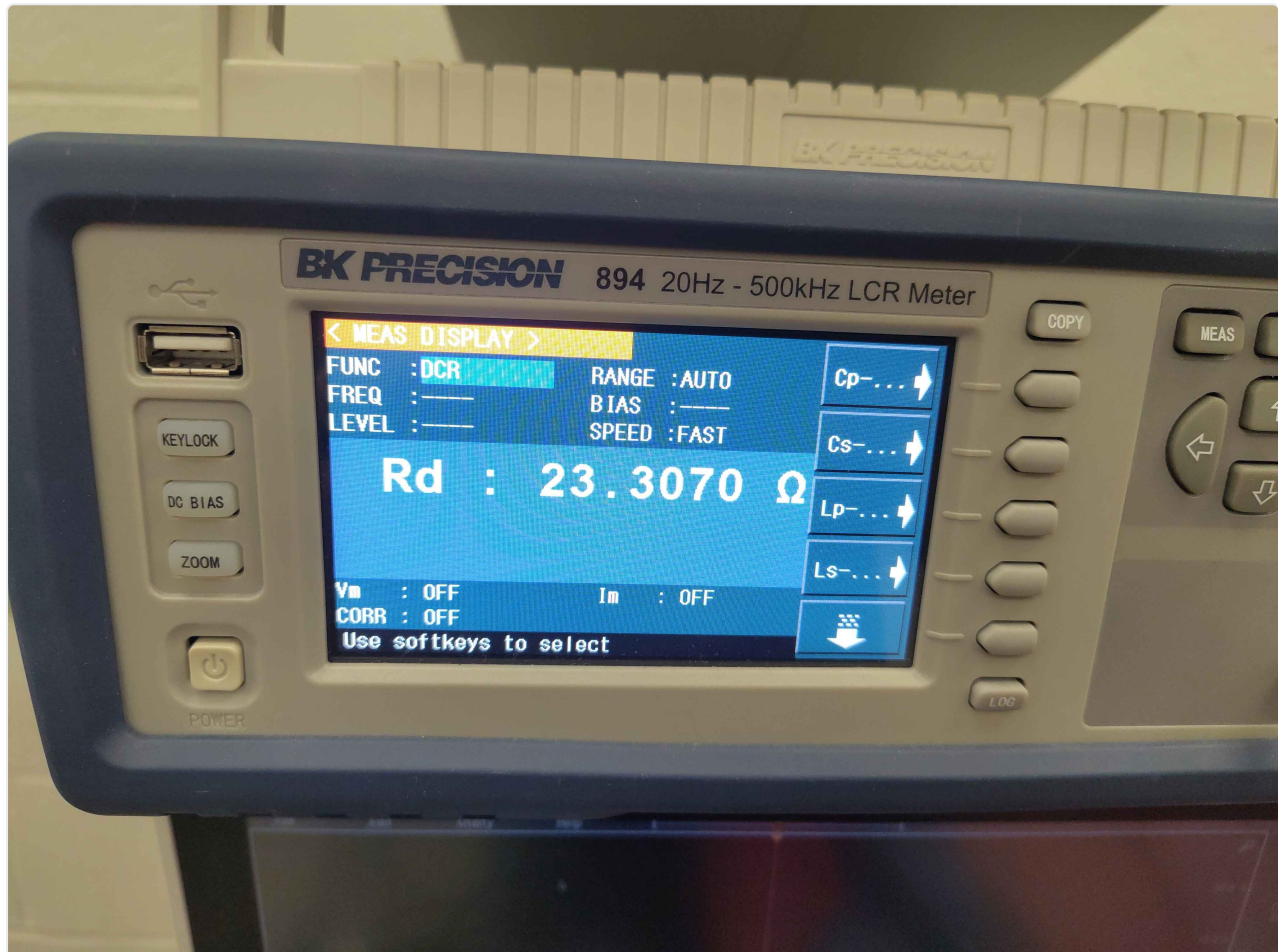
- **Instrument:** BK Precision 894 20 Hz - 500 kHz LCR Meter
- **Function:** DCR

- **Range:** AUTO
- **Speed:** FAST

| Parameter | Value |
| Rd | 23.3070 $\Omega$ |

The reading is about 9 % low (20.94  $\Omega$  vs 23.31  $\Omega$  reference). That is expected for this test point because the current was pushed down by the high resistance load.
